5.2 Lam's observations and theory of collapse

5.3 Probable cause of collapse and sequence of events:

5.4 Full extent of damage

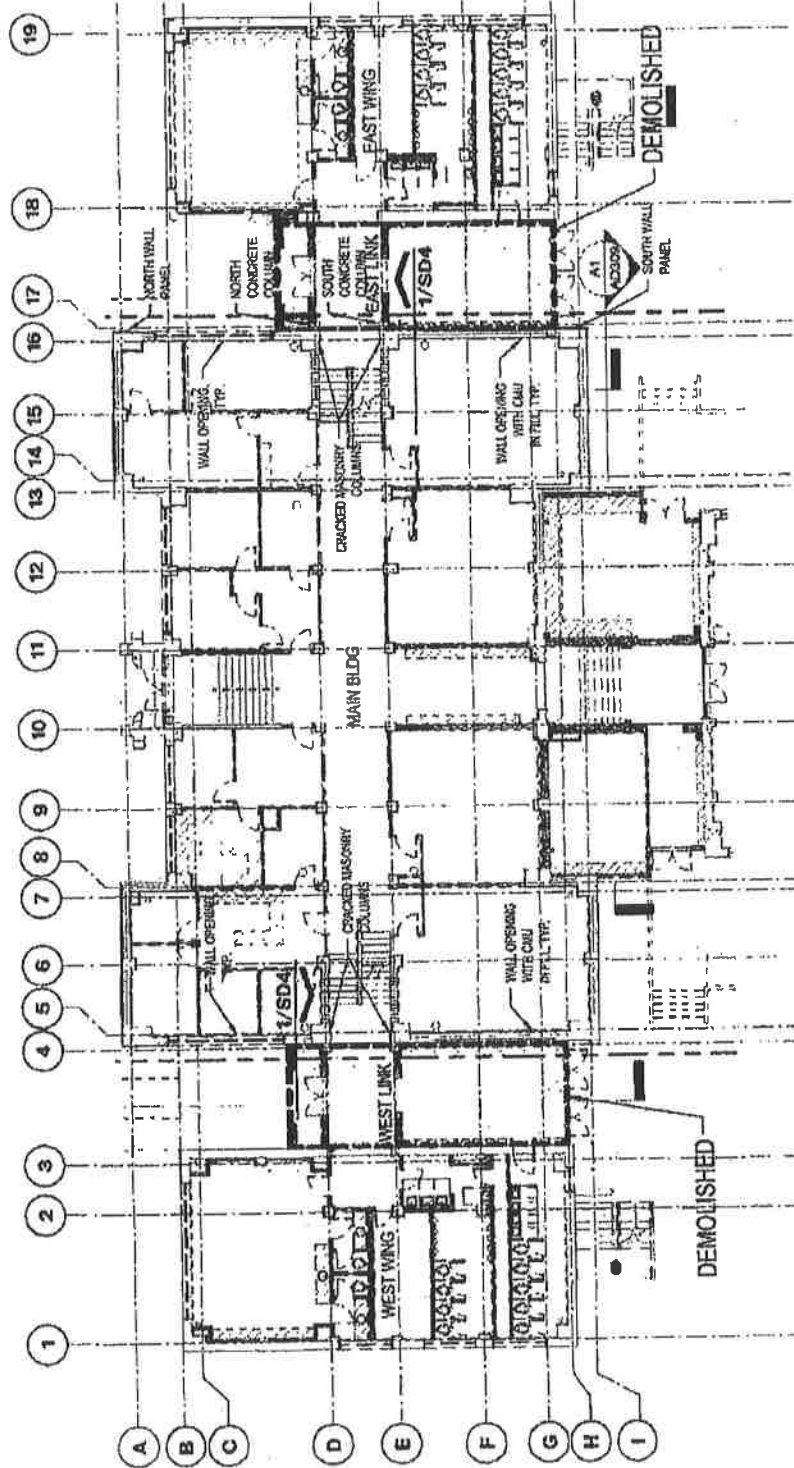
EXHIBIT 8

On October 18, 2010 Frank Lam & Associates, Inc. reported on their investigation of the Partial Collapse of the Main Building and included in their report diagramed information pertaining to the damage areas. Refer to Exhibits 8, 9, 10 and 11.

- **"East Link** - The East Link structure was completely demolished with the exception of some rebar spanning between the buildings. During the demolition of the link, an approximately 12 ft by 60 ft long section of the west side of the Main Building was also damaged and collapsed. The collapsed members include the concrete beams and slab at the second floor and roof, load bearing clay tile and brick veneer walls, exterior masonry columns, and concrete masonry unit infill at the wall opening. Part of the second floor and roof slab is still hanging by the rebar and the two wing walls at the north and south of the building are still remaining but have suffered severe damages and separation. The floor and roof beams had rotated and pulled out from the masonry walls, leaving a pocket in the walls. It appears that the collapse stops at the first interior beam along Grid 15." See Exhibits 8, 9, 10 and 11.

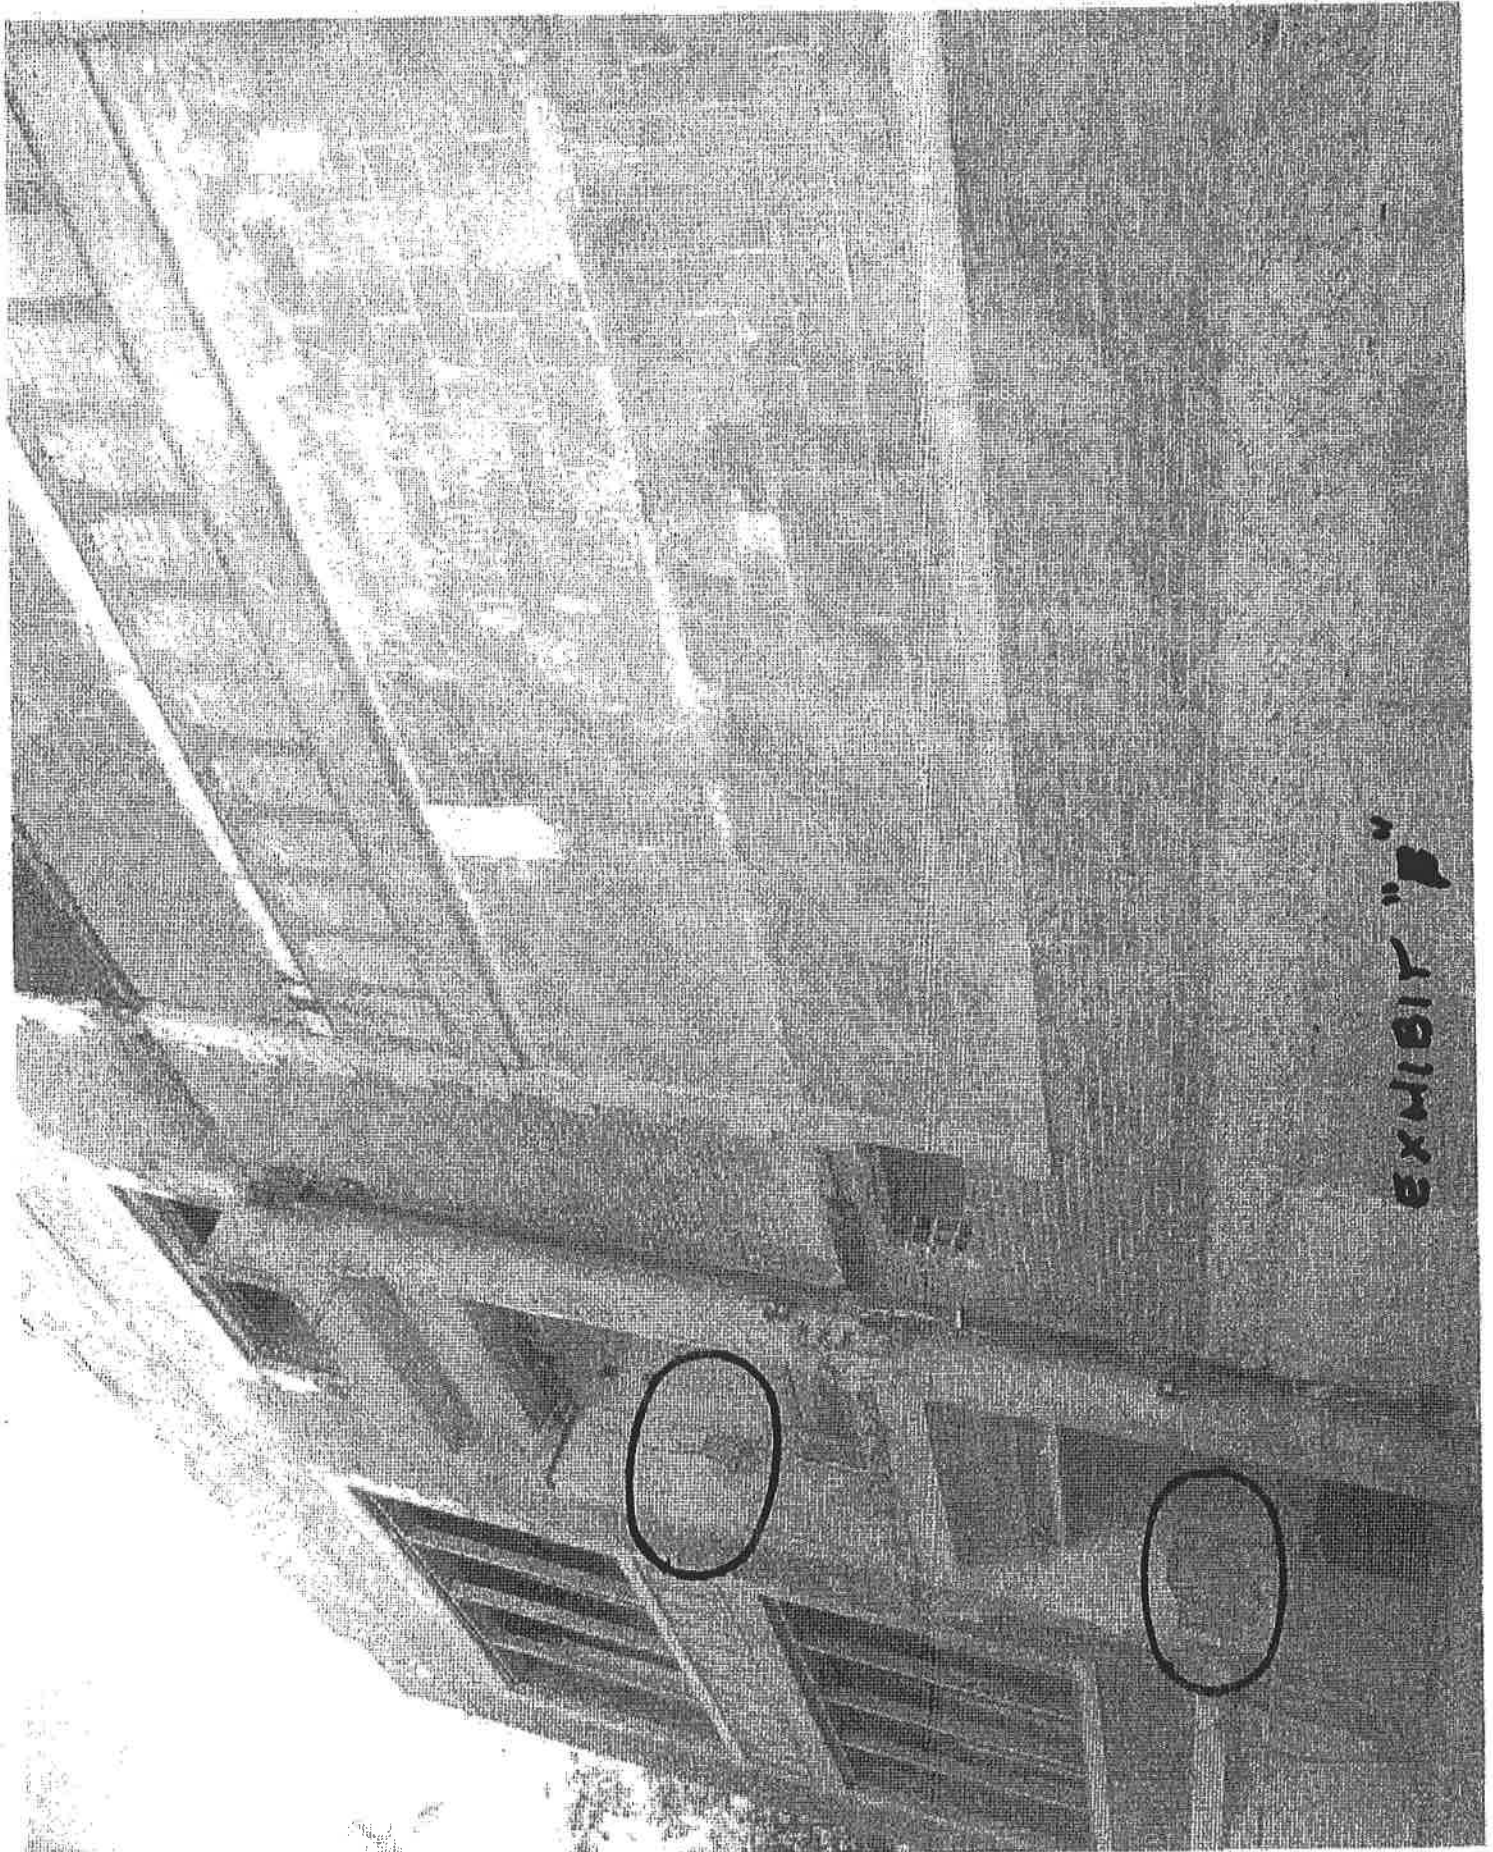
EXHIBIT 18

Mr. Morris addressed the west end of the building stating (page 5): "Inspection of the west end of the main building indicated the concrete columns at the sides of the west exit ended near the level of the first floor, with masonry columns extending above that level. We observed cracking in the masonry columns on both sides of the exit above the first-floor level. Concrete columns had been installed at the exterior of the main building for the walkway... (and) there was evidence of movement of the brick veneer on the first floor at the northern portion of the west wall of the main building." See Exhibit 18.

- e) Mr. Morris addressed the west end of the building stating (page 5): "Inspection of the west end of the main building indicated the concrete columns at the sides of the west exit ended near the level of the first floor, with masonry columns extending above that level. We observed cracking in the masonry columns on both sides of the exit above the first-floor level. Concrete columns had been installed at the exterior of the main building for the walkway... (and) there was evidence of movement of the brick veneer on the first floor at the northern portion of the west wall of the main building."

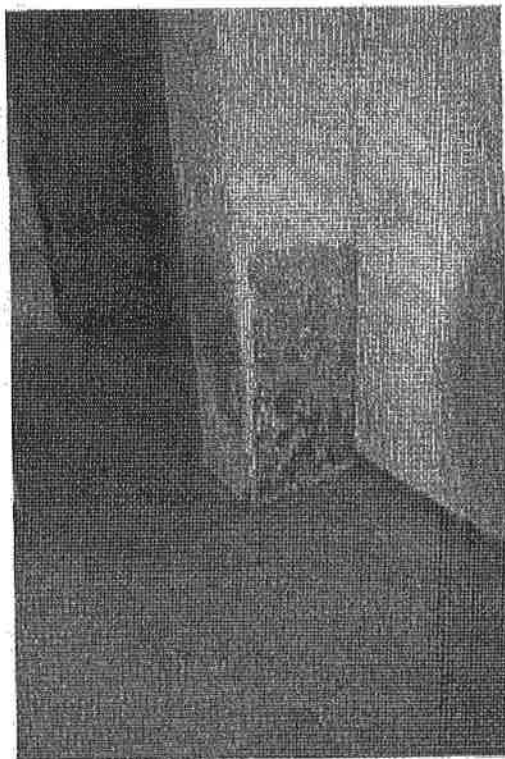
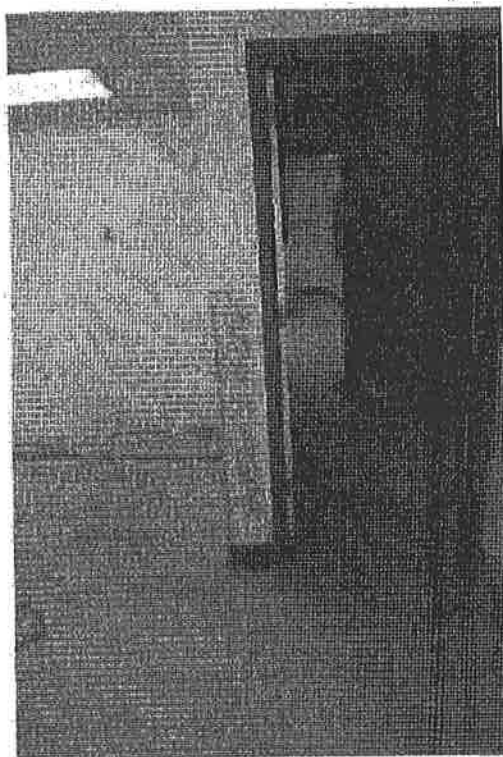
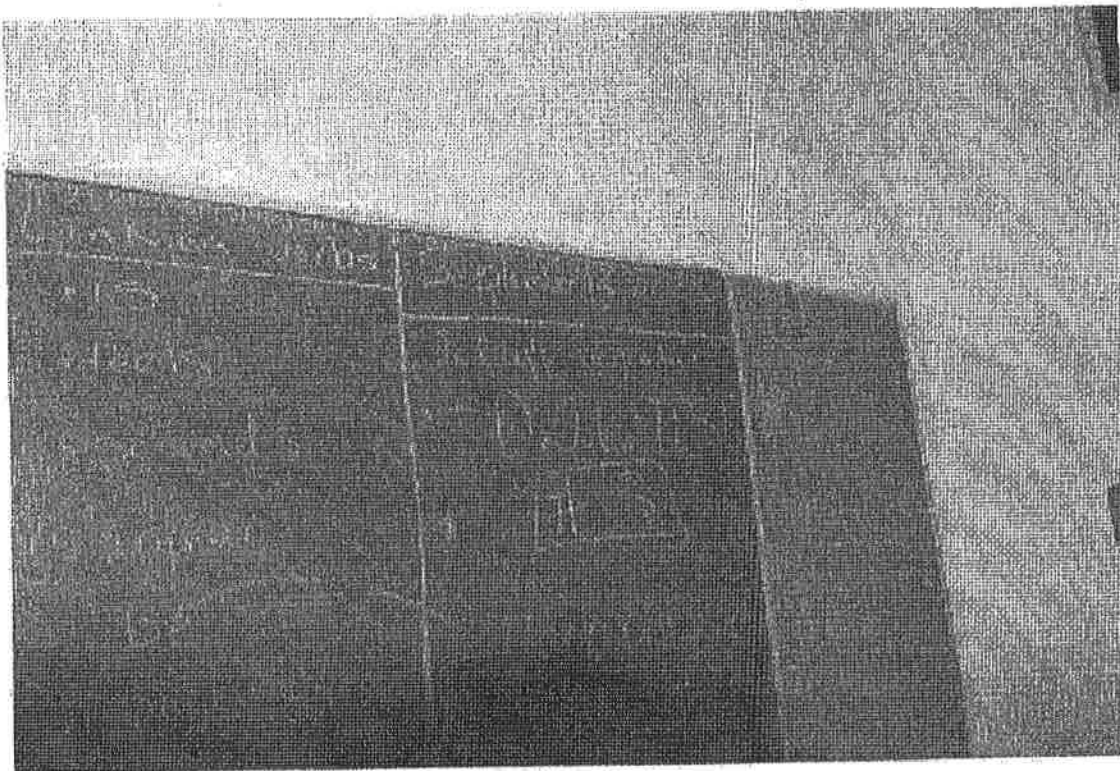
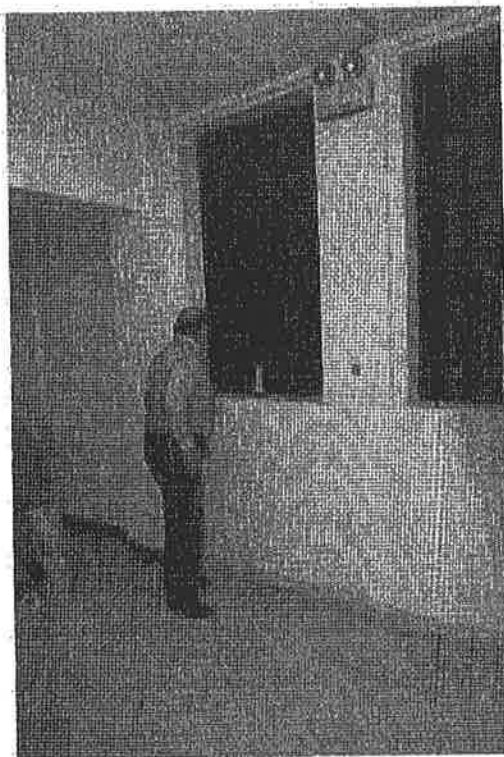
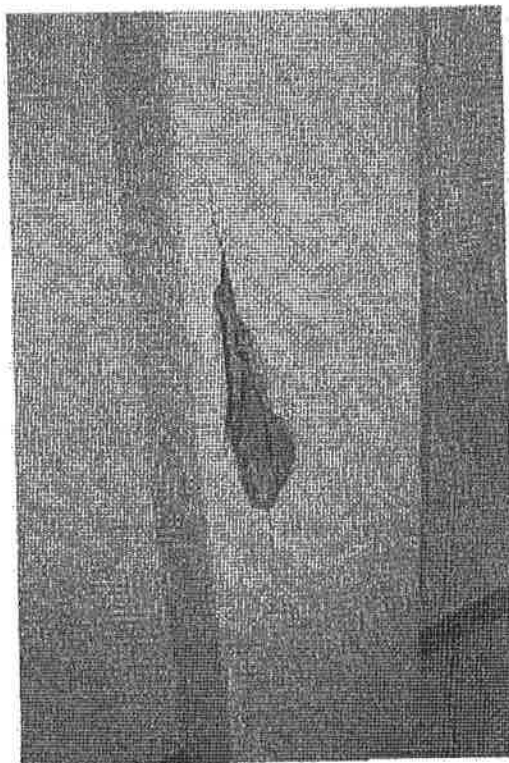
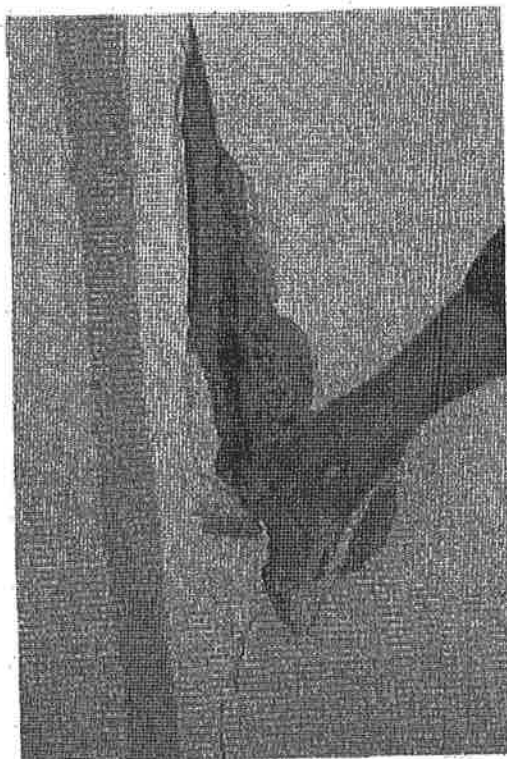
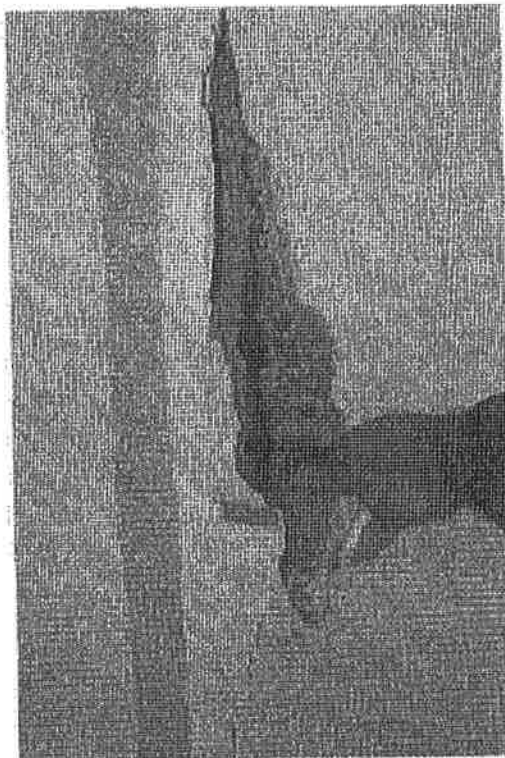
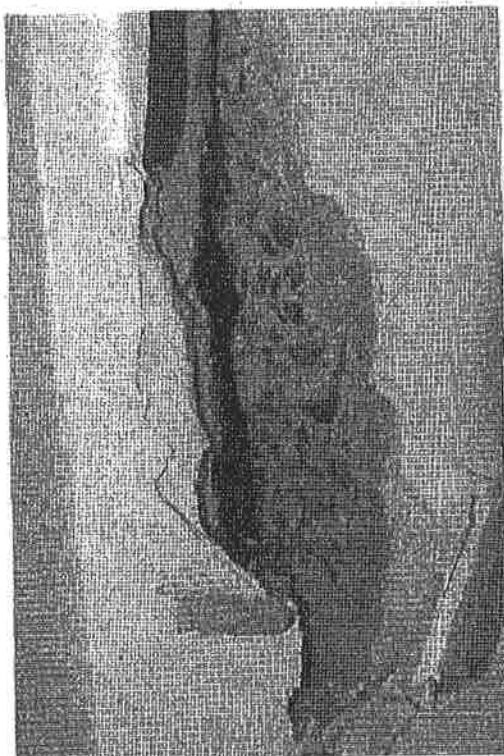
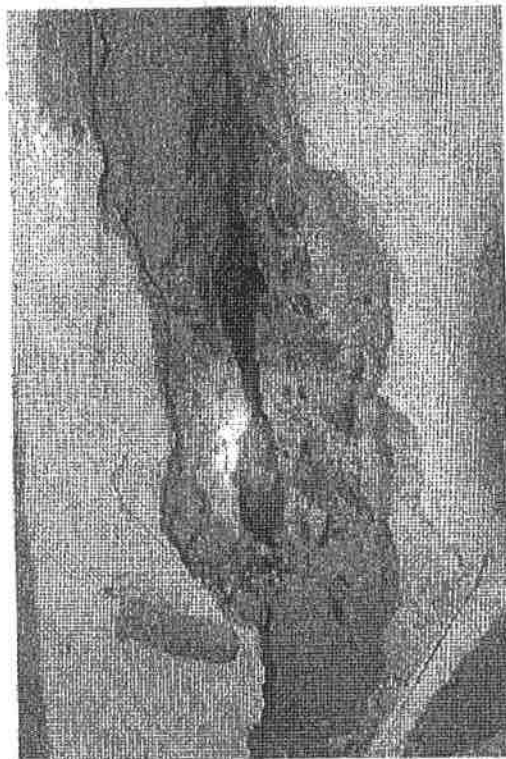
EXHIBIT 19

The basement of the Main Building had evidently previously flooded at one time (see Exhibit 19) and moisture intrusion inside the basement has continued to be a problem.

PHOTOS TAKEN
2/18/2009
ERO PHOTOS
FOUND IN LAM
FILE
